Flood Control Project Maintenance
2016 Structure Summary Report
Overall Unit and Item Ratings

Reclamation District No. 2063 Crows Landing

Lateral No. 6 Pumping Plant

Flood Control Project Maintenance**Unit Cover Sheet****2016 Pumping Plant Inspection Results****Reclamation District No. 2063 Crows Landing**

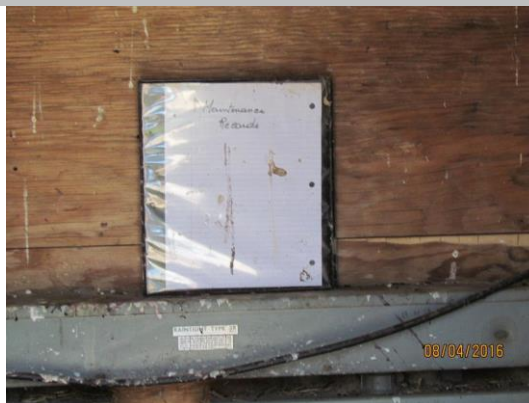
Photo 1 of 1 : ST_2016_RD2063_53_1_20160810_00013.jpg

LM Start	0.00	Rating **	A	Issue No.	1
LM End	0.00	Issue Type +	Ma	Location *	
Category	Pump Stations			GPS Latitude/Longitude	
				Start	End
Item	Operating Log			37.397931 °	37.397931 °
				-120.972176 °	-120.972176 °
DWR ID	DWR_RD2063_53_t_2012_1				
Action/Comments					
Inspector Comments: Operation log was completed and up to date.

View of the log book inside the plant.

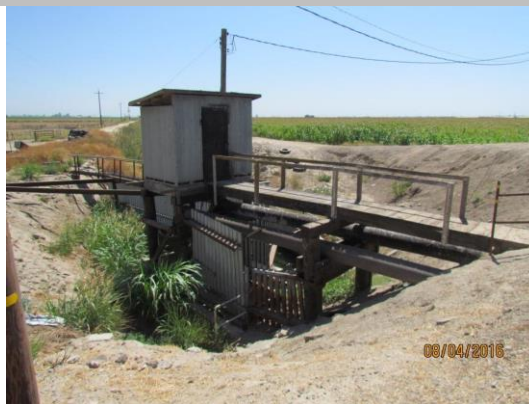
Photo 1 of 1 : ST_2016_RD2063_53_4_20160810_00014.jpg

LM Start	0.00	Rating **	A	Issue No.	4
LM End	0.00	Issue Type +	Ma	Location *	
Category	Pump Stations			GPS Latitude/Longitude	
				Start	End
Item	Plant Building			37.397931 °	37.397931 °
				-120.972176 °	-120.972176 °
DWR ID	DWR_RD2063_53_t_2012_4				
Action/Comments					
Inspector Comments: The plant building appeared to be in a good structural condition.

View of the pumping plant.

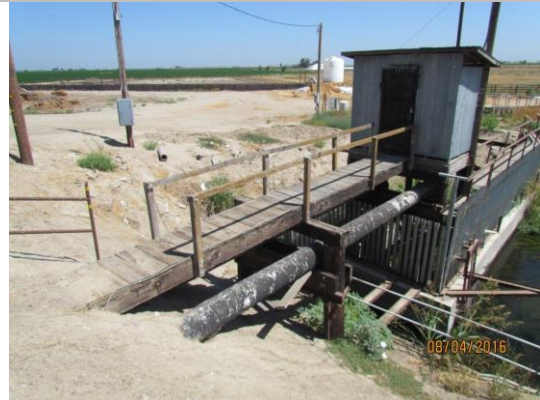
Photo 1 of 1 : ST_2016_RD2063_53_6_20160810_00015.jpg

LM Start	0.00	Rating **	A	Issue No.	6
LM End	0.00	Issue Type +	Ma	Location *	
Category	Pump Stations			GPS Latitude/Longitude	
				Start	End
Item	Safety			37.397931 °	37.397931 °
				-120.972176 °	-120.972176 °
DWR ID	DWR_RD2063_53_t_2012_6				
Action/Comments					
Inspector Comments: There was not any significant safety hazard present outside of the pumping plant during inspection and the handrails prevented falling hazards around the pumping plant.

View of the handrails.

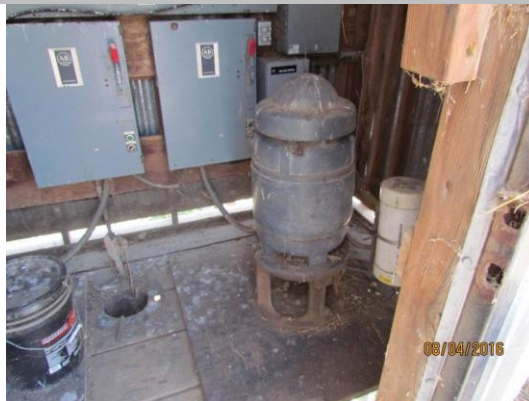
Photo 1 of 2 : ST_2016_RD2063_53_7_20160810_00017.jpg

LM Start	0.00	Rating **	A	Issue No.	7
LM End	0.00	Issue Type +	Ma	Location *	
Category	Pump Stations			GPS Latitude/Longitude	
				Start	End
Item	Pumps			37.397931 °	37.397931 °
				-120.972176 °	-120.972176 °
DWR ID	DWR_RD2063_53_t_2013_7				
Action/Comments					
Inspector Comments: Pumps appeared to be in a good working condition.

View of one of the pumps inside the plant.

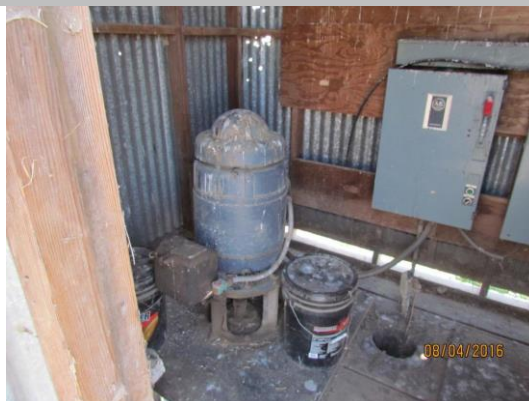
Photo 2 of 2 : ST_2016_RD2063_53_7_20160810_00016.jpg

View of the second pump inside the plant.

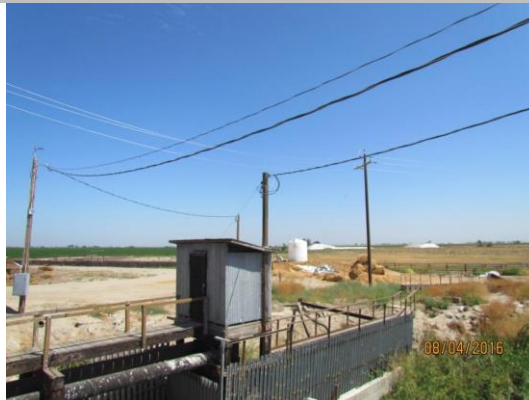
Photo 1 of 1 : ST_2016_RD2063_53_9_20160810_00018.jpg

LM Start	0.00	Rating **	A	Issue No.	9
LM End	0.00	Issue Type +	Ma	Location *	
Category	Pump Stations			GPS Latitude/Longitude	
				Start	End
Item	Power			37.397931 °	37.397931 °
				-120.972176 °	-120.972176 °
DWR ID	DWR_RD2063_53_t_2013_9				
Action/Comments					
Inspector Comments: The power source appeared to be safe and adequate.

View of the power sources for the pumping plant.

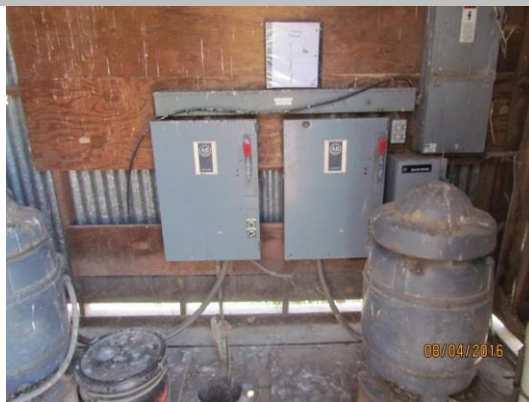
Photo 1 of 2 : ST_2016_RD2063_53_10_20160810_00019.jpg

LM Start	0.00	Rating **	A	Issue No.	10
LM End	0.00	Issue Type +	Ma	Location *	
Category	Pump Stations			GPS Latitude/Longitude	
				Start	End
Item	Pump Control Systems			37.397931 °	37.397931 °
				-120.972176 °	-120.972176 °
DWR ID	DWR_RD2063_53_t_2012_10				
Action/Comments					
Inspector Comments: Pump control systems were operational and in good condition.

View of the power control systems inside the plant.

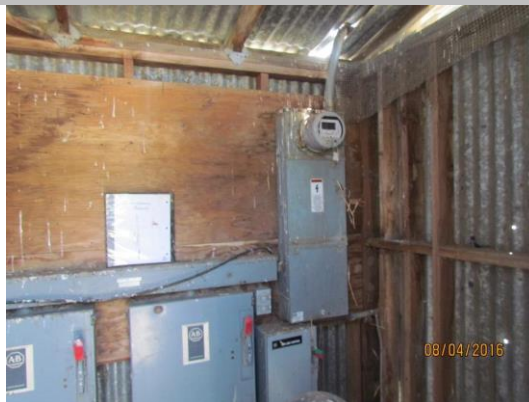
Photo 2 of 2 : ST_2016_RD2063_53_10_20160810_00020.jpg

View of the power meter.

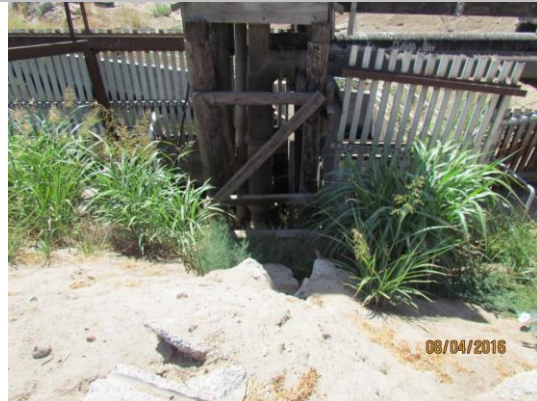
Photo 1 of 1 : ST_2016_RD2063_53_12_20160810_00021.jpg

LM Start	0.00	Rating **	A	Issue No.	12
LM End	0.00	Issue Type +	Ma	Location *	
Category	Pump Stations			GPS Latitude/Longitude	
				Start	End
Item	Sumps/Wet Well			37.397931 °	37.397931 °
				-120.972176 °	-120.972176 °
DWR ID	DWR_RD2063_53_t_2012_12				
Action/Comments					
Inspector Comments: The sump well was free of debris.

View of sump well.

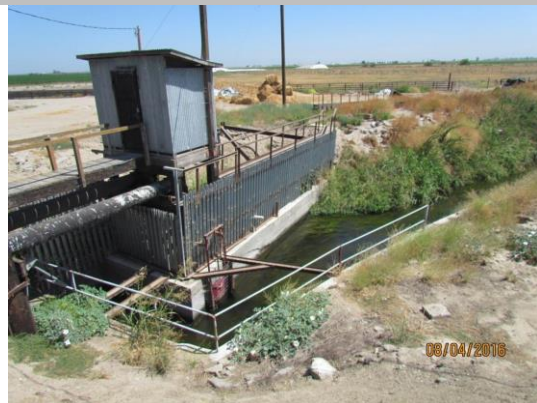
Photo 1 of 1 : ST_2016_RD2063_53_13_20160810_00022.jpg

LM Start	0.00	Rating **	A	Issue No.	13
LM End	0.00	Issue Type +	Ma	Location *	
Category	Pump Stations			GPS Latitude/Longitude	
				Start	End
Item	Trash Racks			37.397931 °	37.397931 °
				-120.972176 °	-120.972176 °
DWR ID	DWR_RD2063_53_t_2012_13				
Action/Comments					
Inspector Comments: The trash racks appears to be in good working condition.

View of the trash rack.

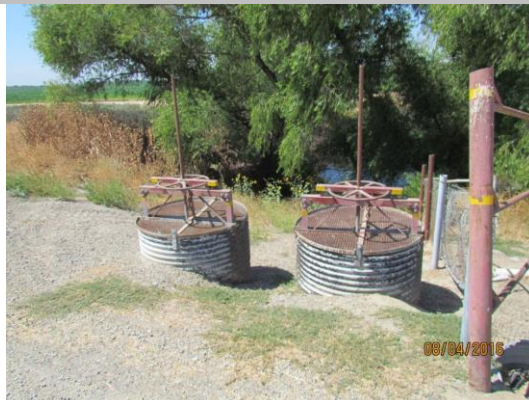
Photo 1 of 1 : ST_2016_RD2063_53_17_20160810_00024.jpg

LM Start	0.00	Rating **	A	Issue No.	17
LM End	0.00	Issue Type +	Ma	Location *	
Category	Pump Stations			GPS Latitude/Longitude	
				Start	End
Item	Manual Gate Operators			37.397931 °	37.397931 °
				-120.972176 °	-120.972176 °
DWR ID	DWR_RD2063_53_t_2012_17				
Action/Comments					
Inspector Comments: The manual gate operator appeared to be in working condition.

View of the manual gates.

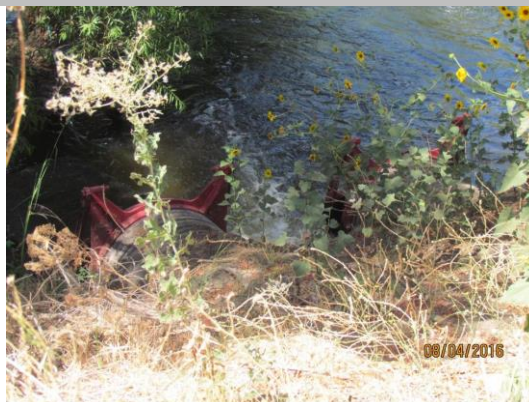
Photo 1 of 1 : ST_2016_RD2063_53_16_20160810_00023.jpg

LM Start	0.00	Rating **	A	Issue No.	16
LM End	0.00	Issue Type +	Ma	Location *	
Category	Pump Stations			GPS Latitude/Longitude	
				Start	End
Item	Flap Gates			37.397931 °	37.397931 °
				-120.972176 °	-120.972176 °
DWR ID	DWR_RD2063_53_t_2013_16				
Action/Comments					
Inspector Comments: Flap gates appeared to be in a good working condition.

View of the flap gates.

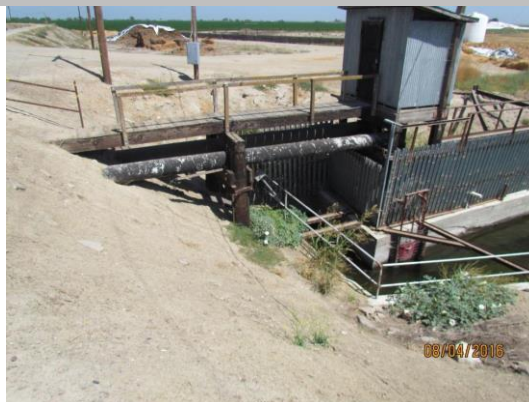
Photo 1 of 1 : ST_2016_RD2063_53_20_20160810_00025.jpg

LM Start	0.00	Rating **	A	Issue No.	20
LM End	0.00	Issue Type +	Ma	Location *	
Category	Pump Stations			GPS Latitude/Longitude	
				Start	End
Item	Intake and Discharge Pipes			37.397931 °	37.397931 °
				-120.972176 °	-120.972176 °
DWR ID	DWR_RD2063_53_t_2013_20				
Action/Comments					
Inspector Comments: The intake and discharge pipes appeared to be in good condition.

View of the intake pipes.
